Graduate student research papers

Floodplain Restoration at the Old Orick Mill Site

Chandra Vogt, Eiji Jimbo, Jason Lin, Daniela Corvillon

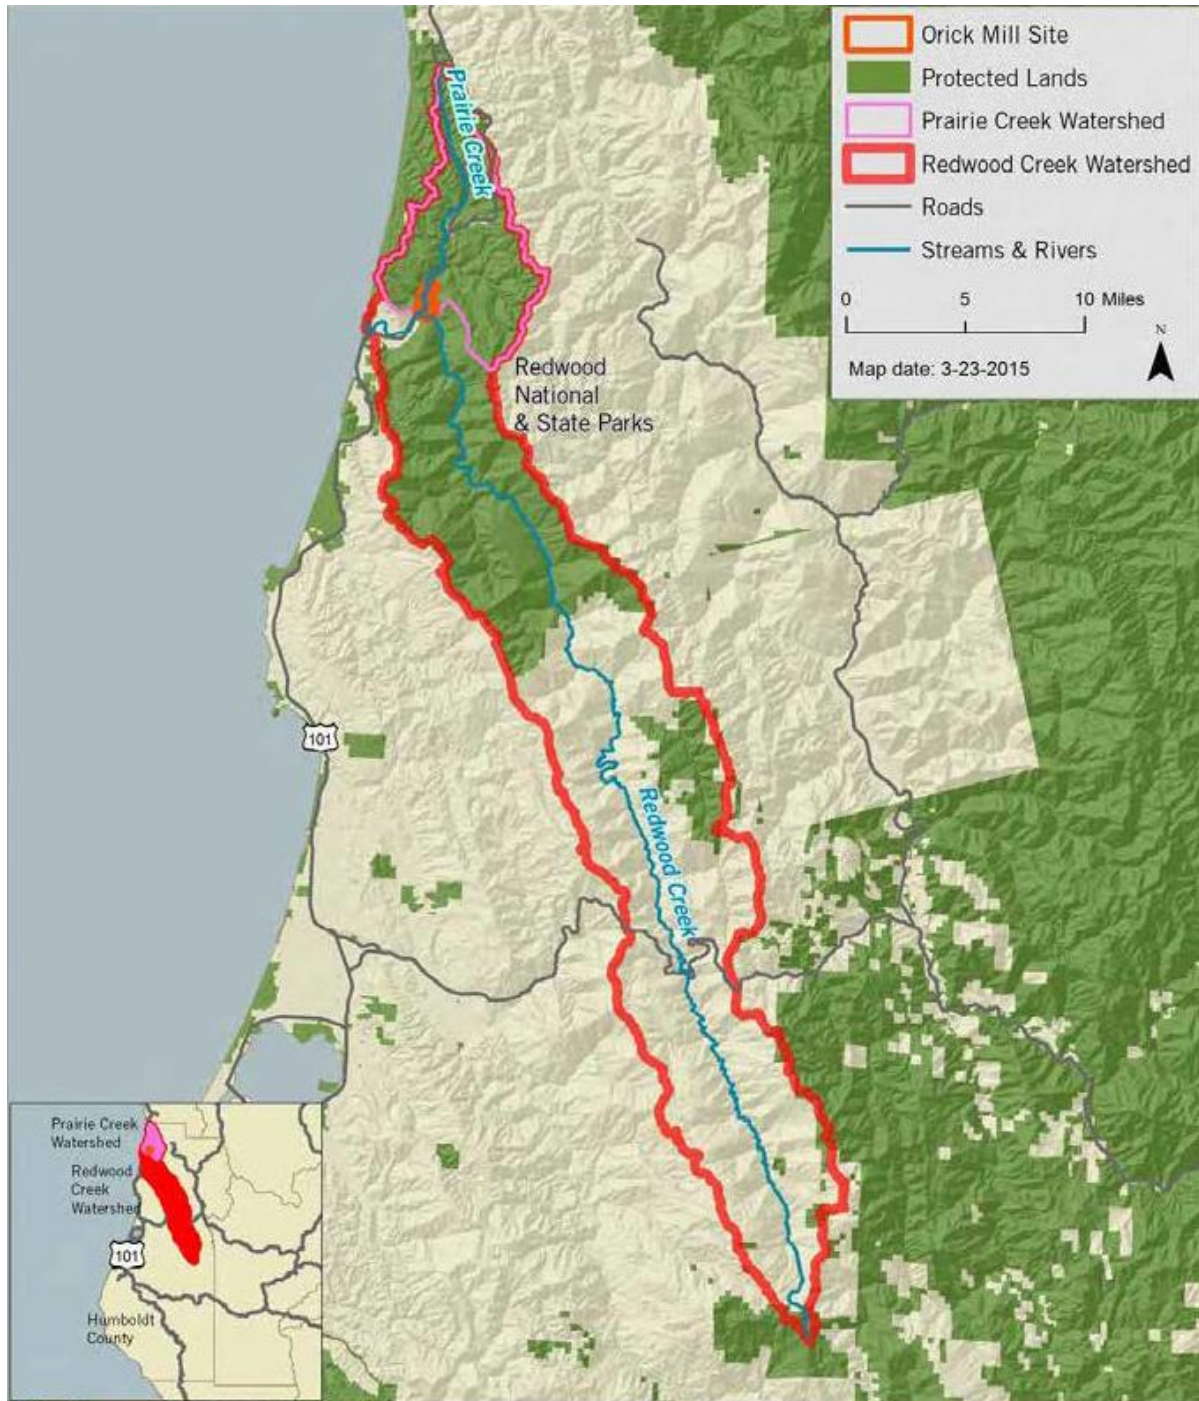
Figure 1. Redwood Creek Watershed and Prairie Creek Sub-Watershed map from Save the Redwoods League

The old Orick Mill site is located in the Prairie Creek sub-basin of the Redwood Creek watershed in northwestern California (Figure 1). The mill was constructed in 1955 on the floodplain at the confluence of Redwood and Prairie creeks, at the present-day junction of U.S. Highway 101 and Bald Hills Road, about six miles upstream from the Pacific Ocean (Figures 2 & 4). Here, old-growth redwoods were processed for almost 60 years before the Orick Mill was shut down in 2009. In 2013, the property was purchased by Save the Redwoods League from Green Diamond Resource Co., which owns 400,000 acres of timber land in Del Norte and Humboldt counties. (Triplicate, 2013)

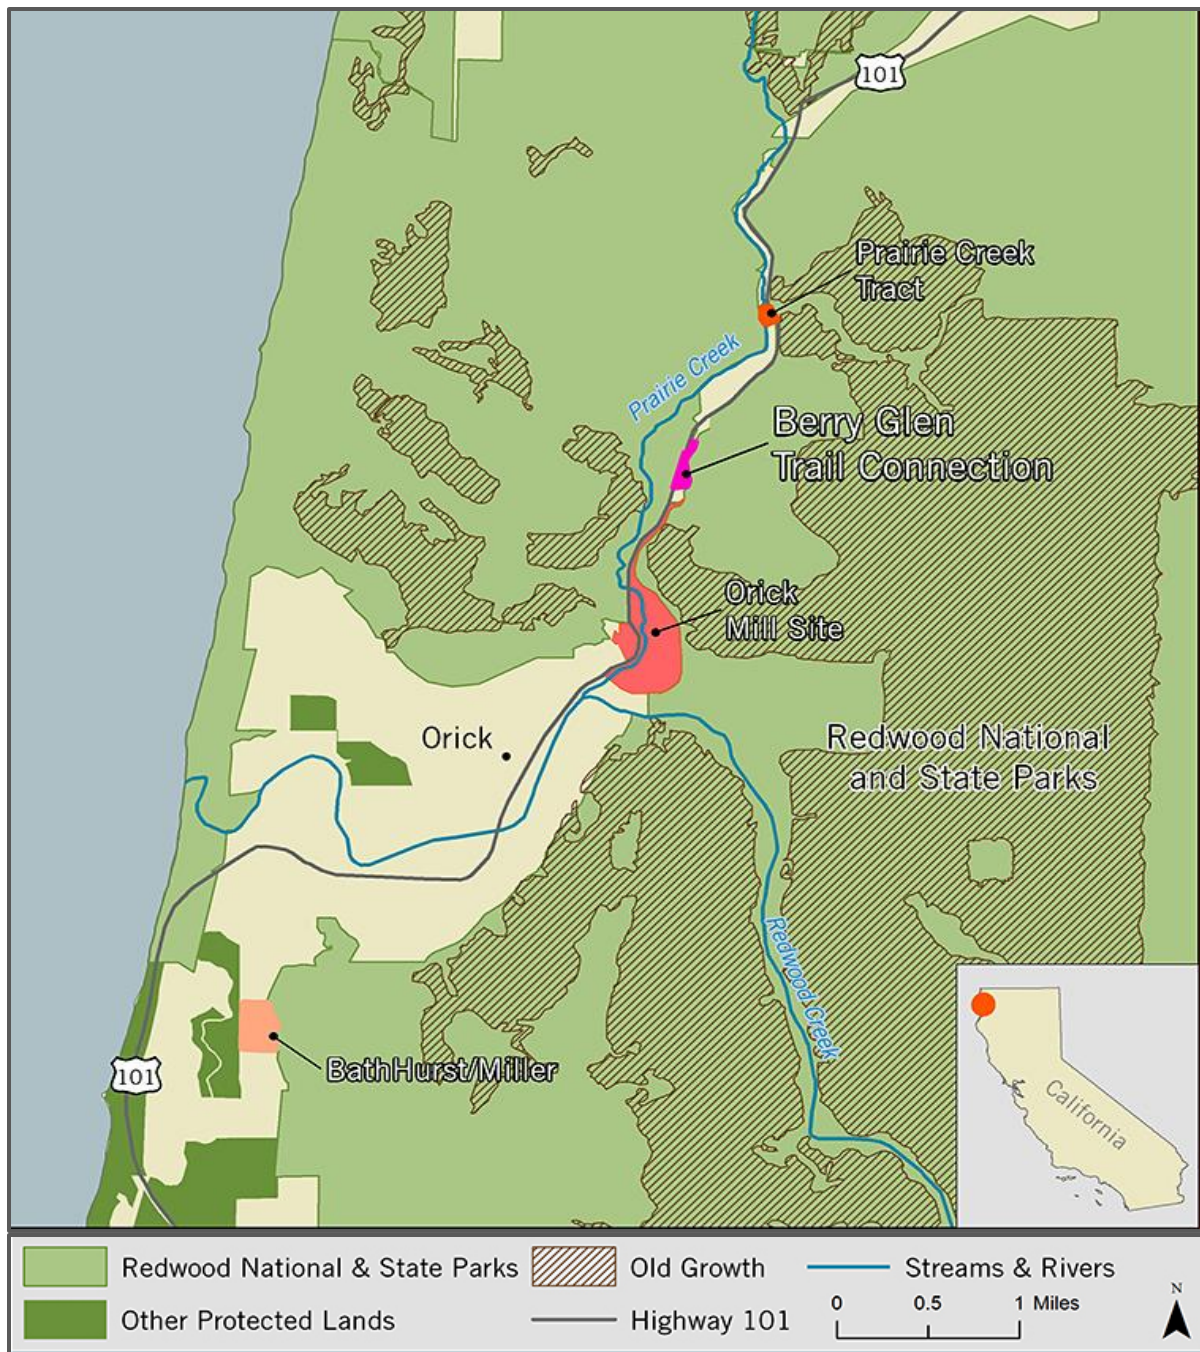
Figure 3. Orick Mill Site, from Save the Redwoods League and Redwood National and State Parks

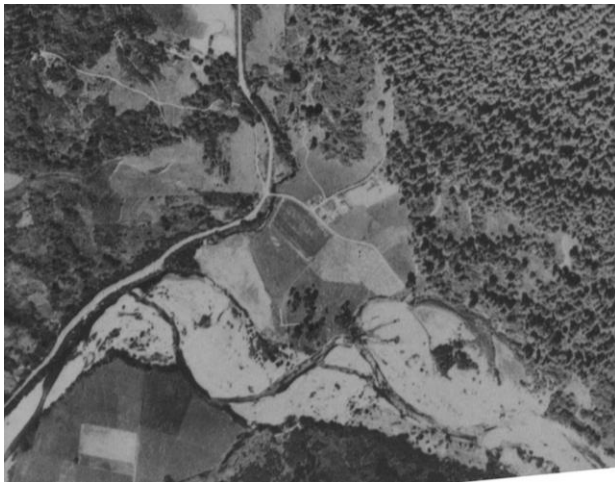
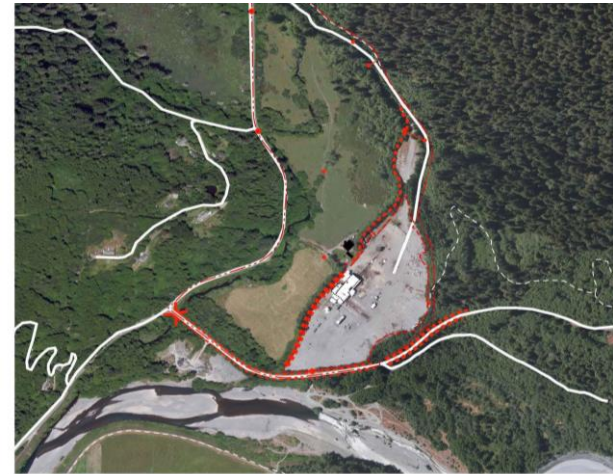
Figures 5 & 6. Aerial photos depicting changes to the floodplain. Left: 1936 Aerial Photo, Right: 2016 Aerial photo with infrastructure highlighted. The range of floodplain was markedly decreased and vegetation took over the edge of floodplain.

The oldest existing photo of the Orick Mill Site was taken in 1931, after some changes in land use had already taken place. An analysis of these photos reveals ongoing changes to the floodplain influenced by historical events since the 1930s. In 1931 and 1936, Redwood Creek was a transient, meandering channel on a wide open floodplain that shifted in response to flood disturbances. During that time the confluence of Prairie

and Redwood Creek covered a wide the floodplain (Figure 5). In later aerials, the floodplain becomes choked by infrastructure, including the construction of the old and new Bald Hills Rd bridges as well as flood control levees. The photos show an accumulation of sediment on the floodplain followed by the propagation of shrubs and large trees along flood control levees and infrastructure developments. (Figure 6)

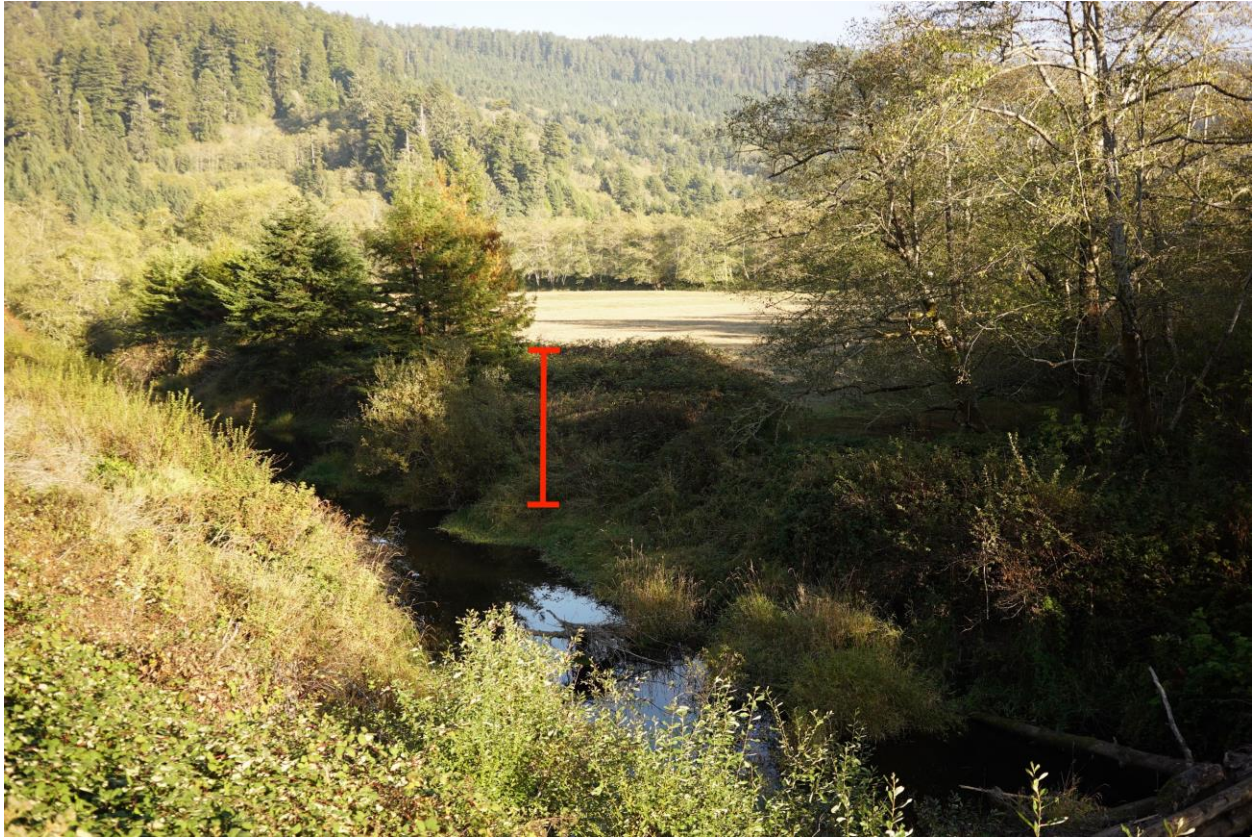
Figure 9. Height drop between floodplain and the Prairie Creek channel

The lateral connectivity of the creeks is severely restricted by several causes. The Old Bald Hills Road, built prior to 1931, acted as a levee, ponding floodwaters and inducing sediment deposition. This has resulted in an elevation difference of three feet between the north side of the mill site and the south pasture. A flood control levee and pasture constructed parallel to Prairie Creek in the 1960s further confined the creek channel and floodplain. The new Bald Hills Road overpass, constructed on fill in the 1960s, cuts through the remaining floodplain at the confluence of Prairie and Redwood Creeks. The new overpass and the adjacent gravel mine built across from the mill site on private property caused an increase in sediment deposition, floodplain elevation and incision of the Prairie Creek Channel (Figures 9 & 10). The construction of Highway 101 in the 1980s further confined the Prairie Creek channel along the east side of its floodplain. Vegetation has gradually taken over the banks along the creeks indicating compromised hydrologic and geomorphic processes of Prairie Creek and reduced lateral connectivity of the floodplain. (Figures 11)

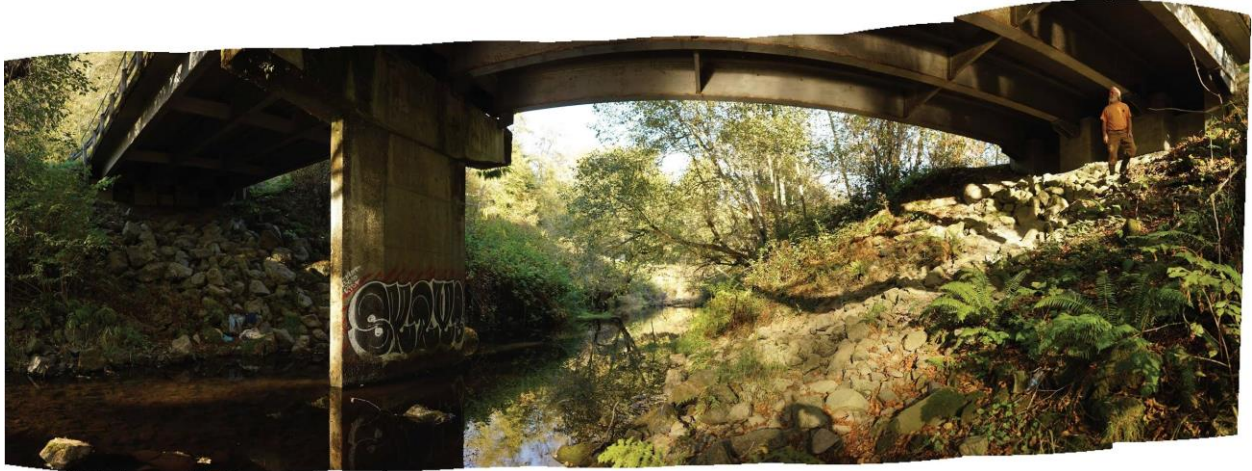
Figure 11. The narrowed Prairie Creek channel and confining structures of New Bald Hill Road overpass from both sides

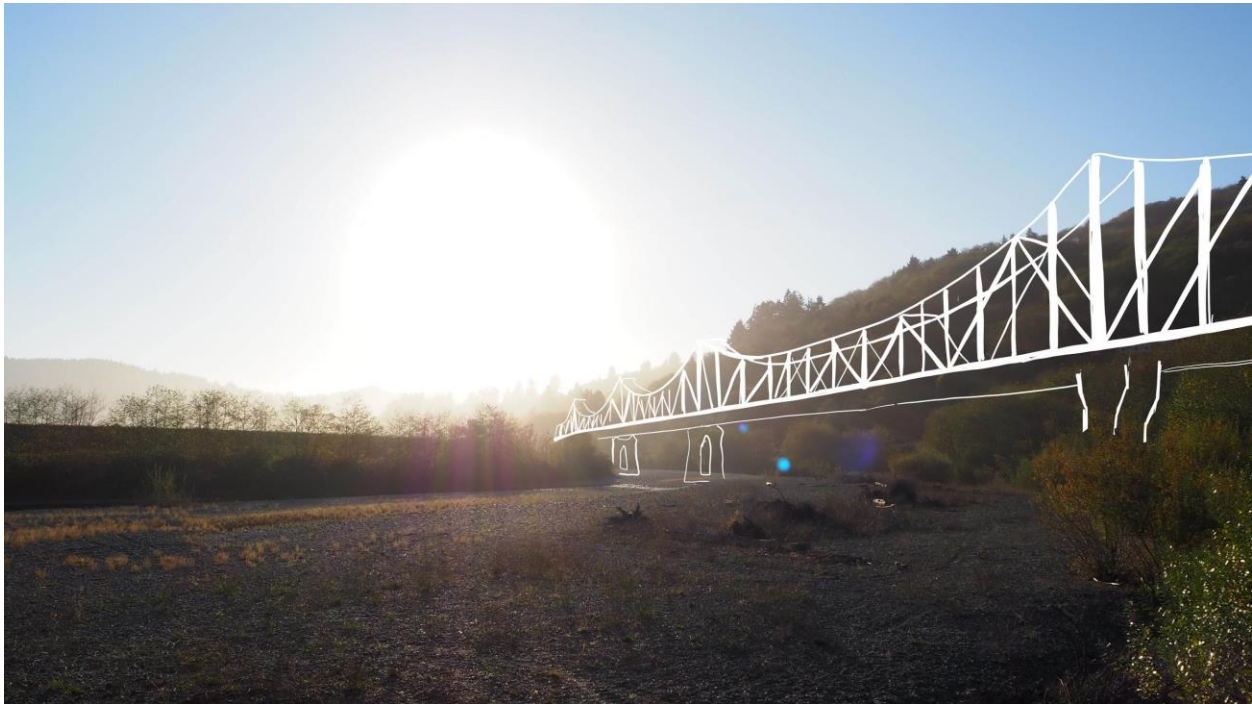
Figure 12. One of the envisioned alternatives to New Bald Hills Road overpass

We suggest widening and relocating the overpass to allow for a larger floodplain . A redesign of the Bald Hills Road overpass to pass flow would allow natural hydrologic and geomorphic cut and fill processes and channel migration thereby improving the floodplain habitats. In order to accomodate variable flood events, the Bald Hill Road levee should be replaced with an elevated roadway passes flow and allows sediment to pass naturally through this system. An elevated roadway such as a mini-causeway or a series of long arch culverts with minimal interference would be ideal solutions (Figure 12). A causeway would enable lateral movement of floodwaters, but the many structural foundations in a typical causeway would still limit sediment transport, requiring maintenance and removal of sediment. Therefore we recommend a longer span bridge with foundations every 30-40 feet. A longer span bridge would allow dynamic movement of the creek and natural cut and fill processes across the gravel bed floodplain.
